Title: Pinion Shaft Fracture Analysis

WHITING CORPORATION  
TRACKMOBILE DIVISION  
FINAL REPORT  
A-3017  
FRACTURE ANALYSIS

## ANALYSIS OF A FRACTURED DRIVE PINION

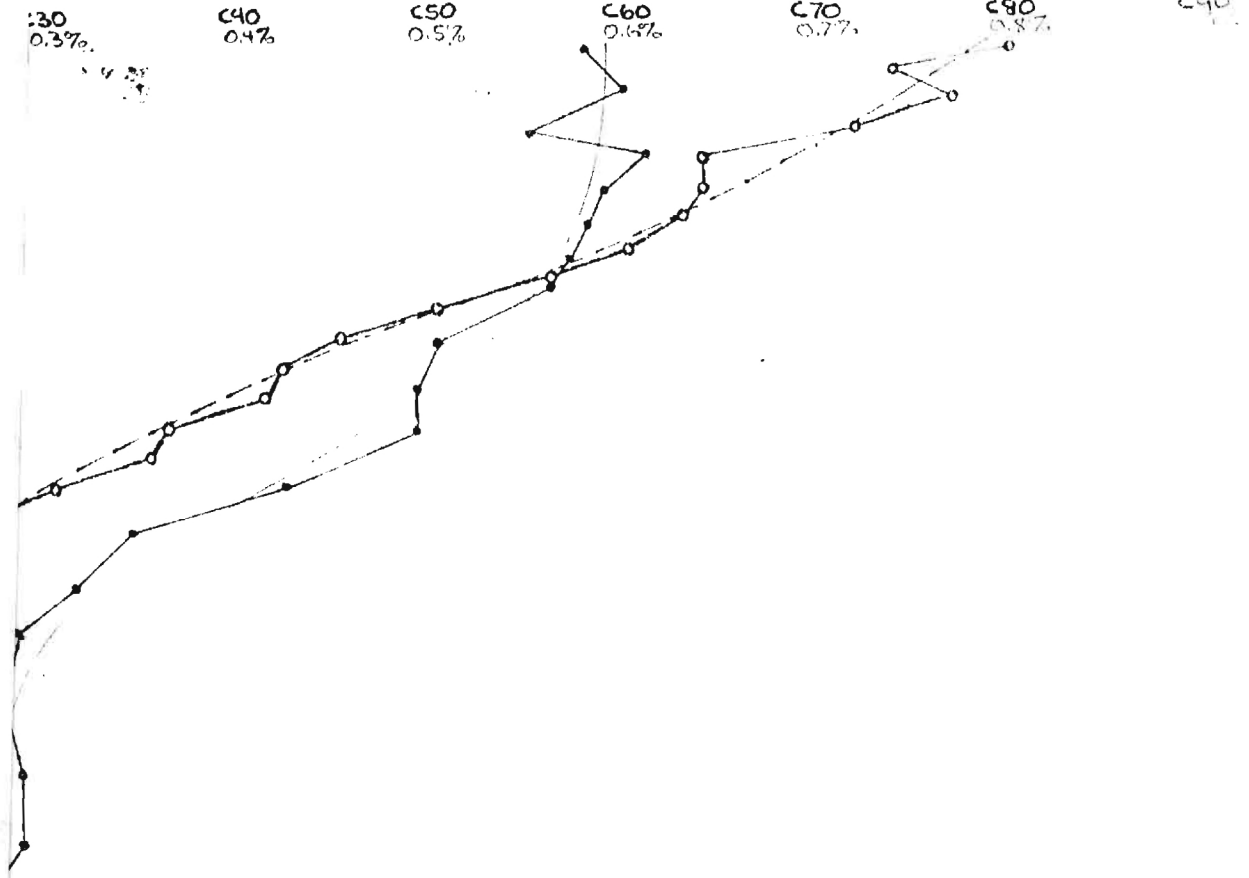
# HARDNESS - ROCKWELL "C" SCALE PER CENT CARBON

A section was cut from the spline end opposite the fracture surface and polished for hardness measurements and elemental analysis. Hardness measurements were made on a Knoop indentation hardness tester and a carbon content trace made on the electron probe microanalyzer. The results of these tests are shown in Graph 1. An elemental analysis was run in the electron probe on an area near the center of the section. The results of this analysis are shown in the following table.

HARDNESS AT CENTER

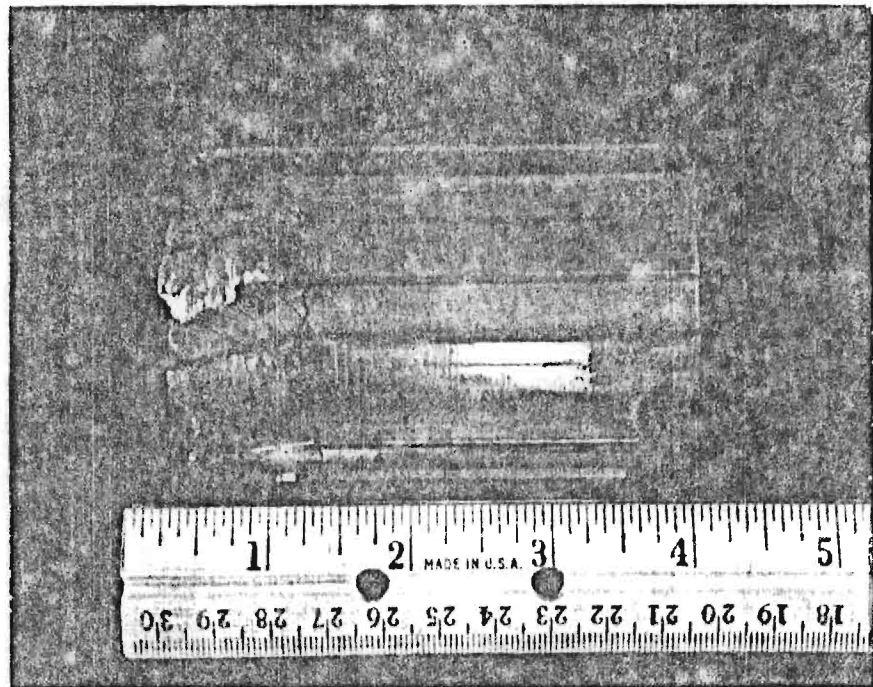
FIGURE 1: FRACTURED SPLINE SHAFT

Figure 1 shows the fractured spline shaft with the exposed fracture surface on the left and many unexposed fractures about an inch to the right of the exposed fracture. The cut out portion on the extreme right of the shaft is the section which was removed for elemental analysis and hardness tests. Cuts were made perpendicular to the exposed fracture surface and across the shaft below the unexposed fractures so that some of the unexposed fractures could be broken open and examined. Figure 2 shows the exposed fracture surface after one such section was removed. After examination of a number of these unexposed fracture surfaces, most of which were very badly rubbed, an area was found which appeared to indicate fatigue. This area was placed in the scanning electron microscope (SEM) for a higher magnification examination. Figure 3 is a low mag. SEM which shows two regions with "beach marks" which are typical of fatigue. Figures 4 and 5 are high magnifications SEM's of the fracture surfaces in these regions. There is a hint of fatigue striations in these micrographs and no other fracture mechanism is apparent. Fatigue striations in a steel such as this are often very difficult to see in the SEM.

From all the data obtained it is concluded that this fracture did occur by reversed torsional fatigue as explained in the Metal Progress article which is included with this report. The high stress intensity created by the sharpness of the radius at the base of the spline teeth is the basic cause of failure.
